# Operating Vibration Test Report

Report No: 1605VO0665

<b>Product Model</b>	<b>8" Rugged Tablet PC : Taurus FM08</b>
<b>Product Description</b>	<b>Rugged Tablet PC</b>
<b>Test Reason</b>	<ul style="list-style-type: none"> <li><input checked="" type="checkbox"/> New product               <ul style="list-style-type: none"> <li><input checked="" type="checkbox"/> Rugged Tablet PC</li> </ul> </li> <li><input type="checkbox"/> Renew product               <ul style="list-style-type: none"> <li><input type="checkbox"/> PCB :</li> <li><input type="checkbox"/> BIOS:</li> </ul> </li> <li><input type="checkbox"/> Revision change               <ul style="list-style-type: none"> <li><input type="checkbox"/> PCB :</li> <li><input type="checkbox"/> BIOS:</li> <li><input type="checkbox"/> Component:</li> </ul> </li> </ul>

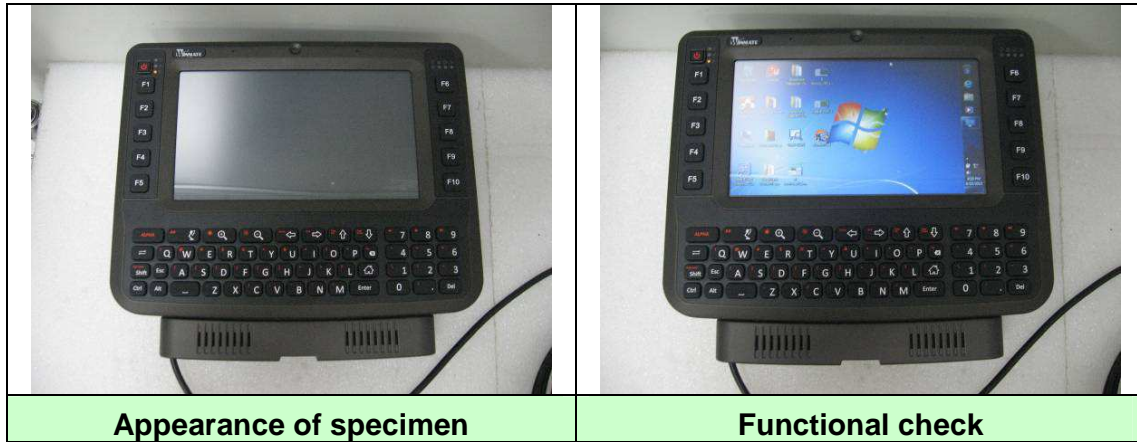
- Compliance of MIL-STD-810G/Method 514.6/Procedure I / Figure 514.6C-3
- Operation
- Random vibration: 5 Hz ~ 500 Hz
- Impact acceleration: 1.48 & 1.90 & 2.24 g rms
- Axis of vibration: Transverse-X, Longitudinal-Y, Vertical-Z
- Duration time: each axis 60 min.
- Total Time: 3 hours
- Quantity: Total 1 Set
- Testing Period: Dec. 16, 2015 to Dec. 16, 2015

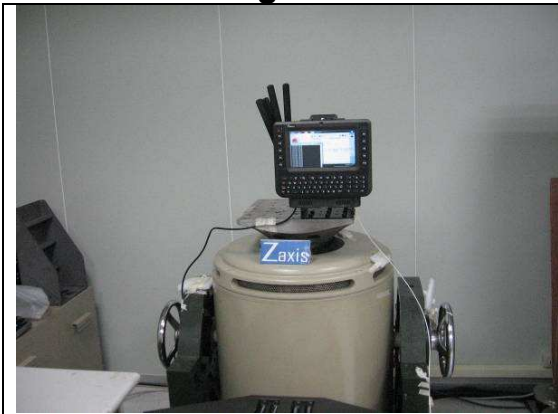
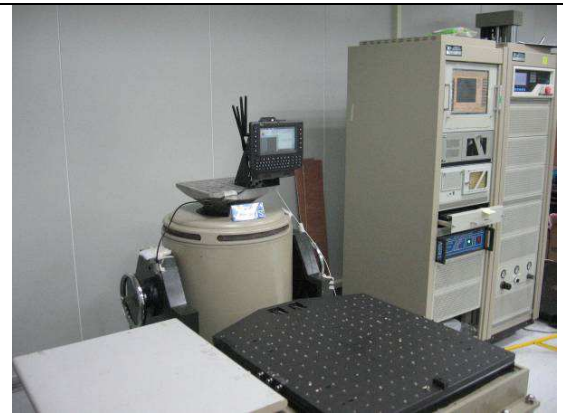
**Operating Vibration Test - Z axis**

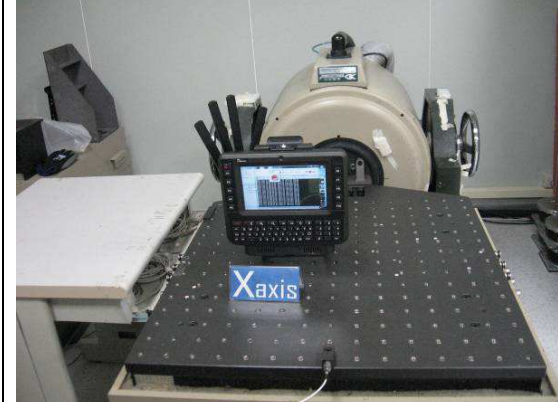
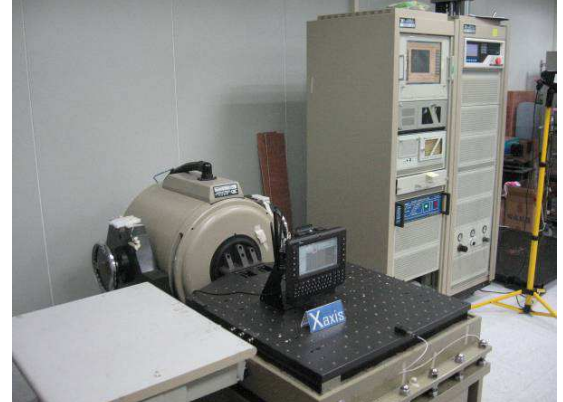
**Operating Vibration Test - X axis**

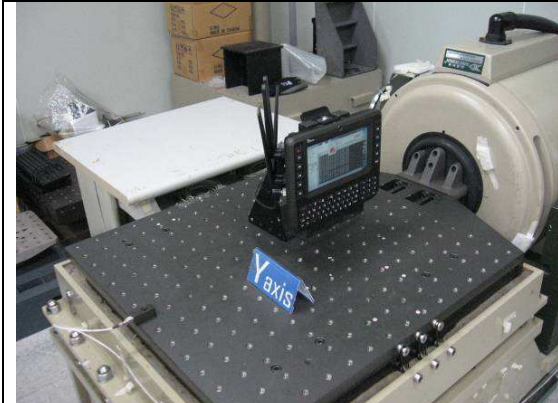
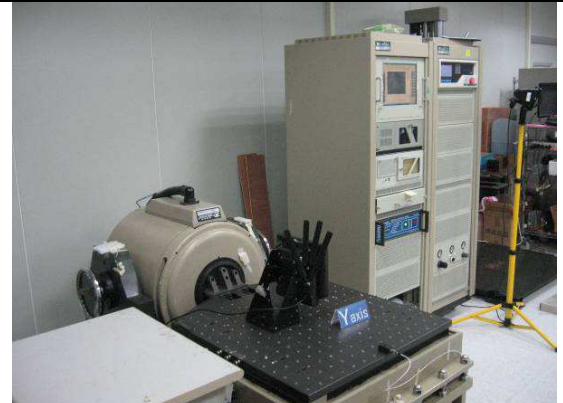
**Operating Vibration Test - Y axis**
