# Operating Shock Test Report

Report No: 1601SK0664BR

<b>Product Model</b>	<b>10.4" Rugged Tablet PC : Taurus FM10</b>
<b>Product Description</b>	<b>Rugged Tablet PC</b>
<b>Test Reason</b>	<input checked="" type="checkbox"/> New product <input checked="" type="checkbox"/> Rugged Tablet PC  <input type="checkbox"/> Renew product <input type="checkbox"/> PCB : <input type="checkbox"/> BIOS:  <input type="checkbox"/> Revision change <input type="checkbox"/> PCB : <input type="checkbox"/> BIOS: <input type="checkbox"/> Component:

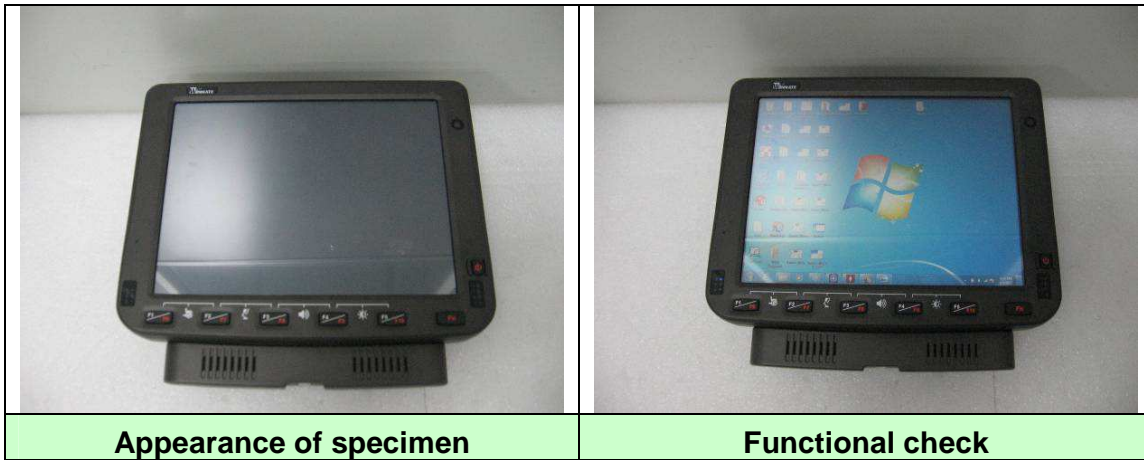
Examine the appearance of specimen(s) by visual check and perform functional check after this test. Connect the specimen with rated power then examine whether the display function of specimen could be work normally or not.

- Functional Check & Mechanical Structure: Normal
- Appearance check (Visual check): No visible damage

Check Item Style Item No.	Appearance check (Visual check)		Functional & Performance check
	Initial	Final	
10.4" Rugged Tablet PC : Taurus FM10	No visible damage	No visible damage	Normal
